ST JAMES CHURCH, QUEDGELEY

Quinquennial Inspection Report 2018

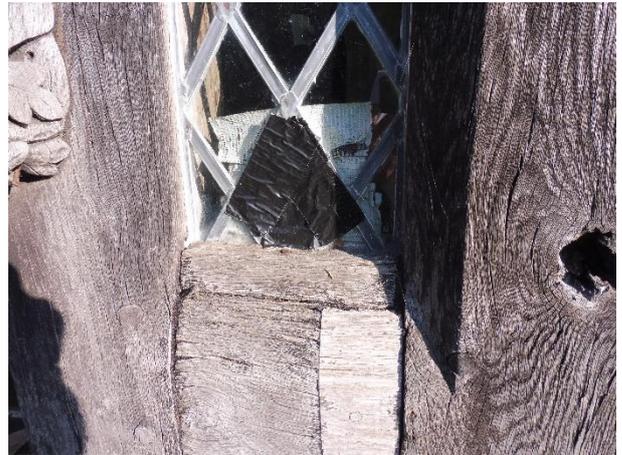
South Porch – Damaged glazing.

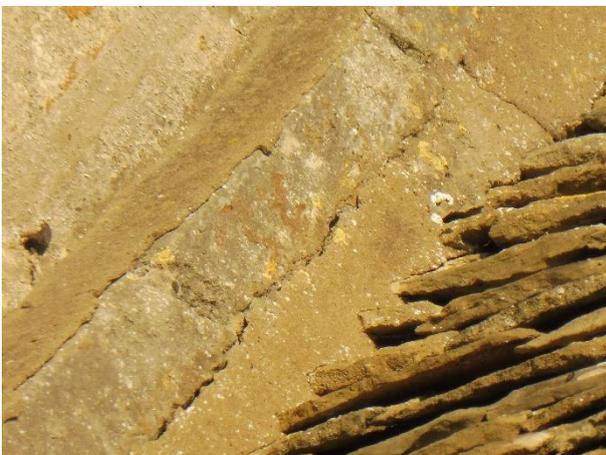
Lady Chapel, south – Cracking to mortar fillet at Tower abutment.

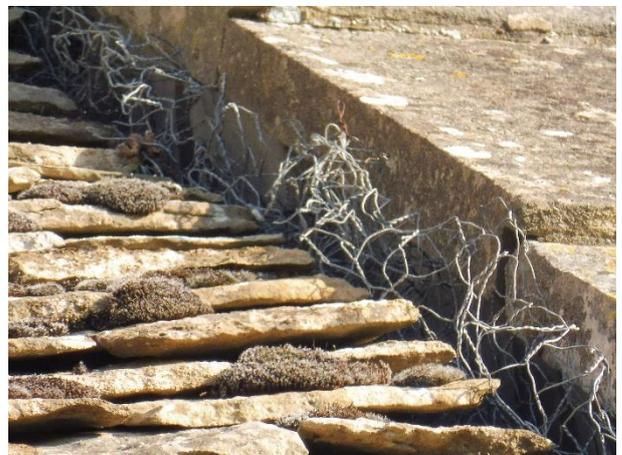
Lady Chapel, south – Wire mesh to lead lined secret gutter.

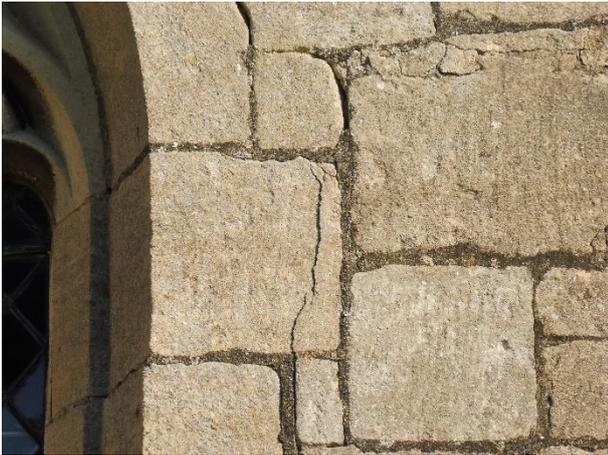
Lady Chapel, south window – Vertical movement and fracture to jamb.

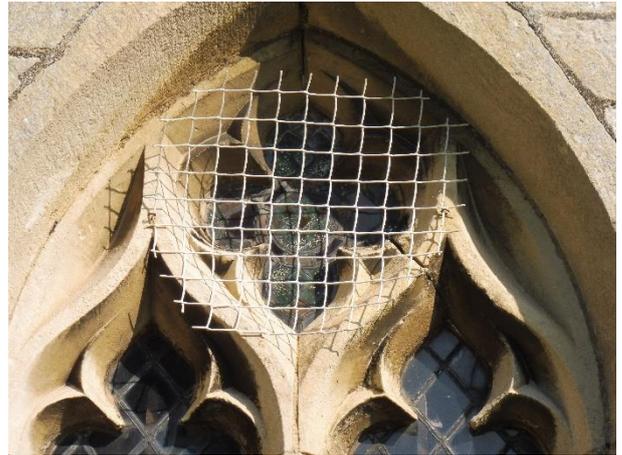
Lady Chapel – Rudimentary and inappropriate window guard.

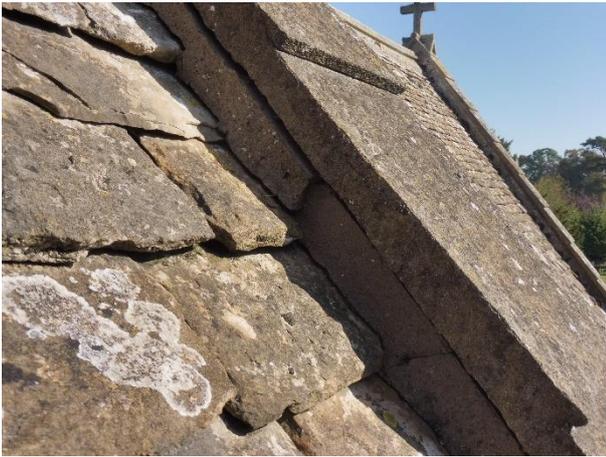
Nave east gable parapet – Cracked/damaged mortar fillet.

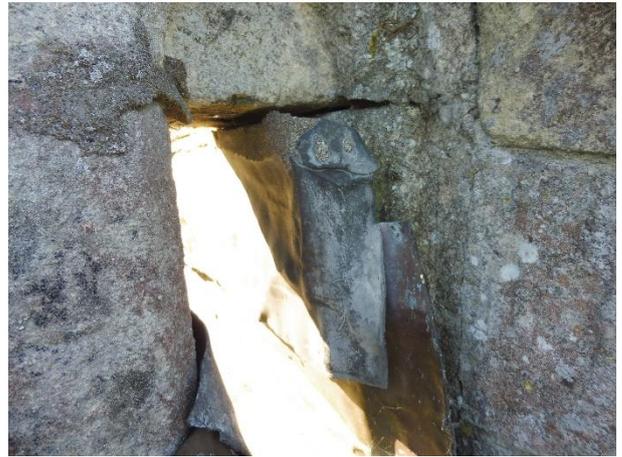
Vestry west lead lined box gutter – Loose and detached cover flashing through outlet.

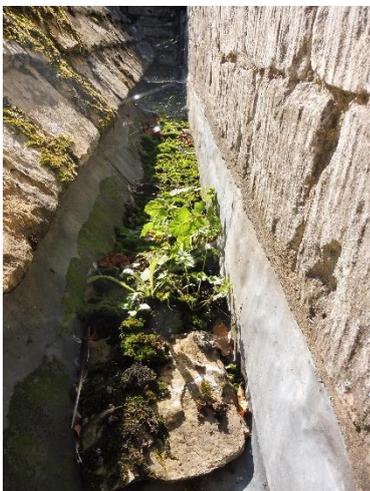
Vestry west lead lined box gutter – Vegetation, moss and debris.

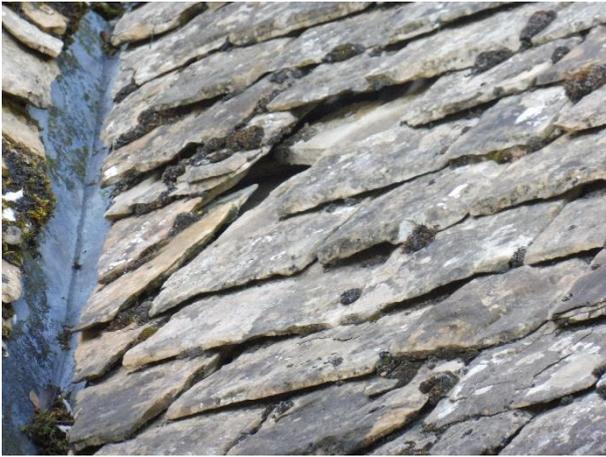
Vestry east – Slipped/missing slates.

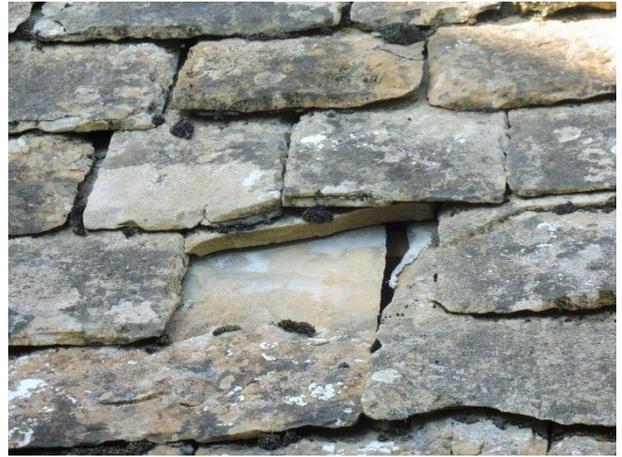
Vestry east – Damaged slate.

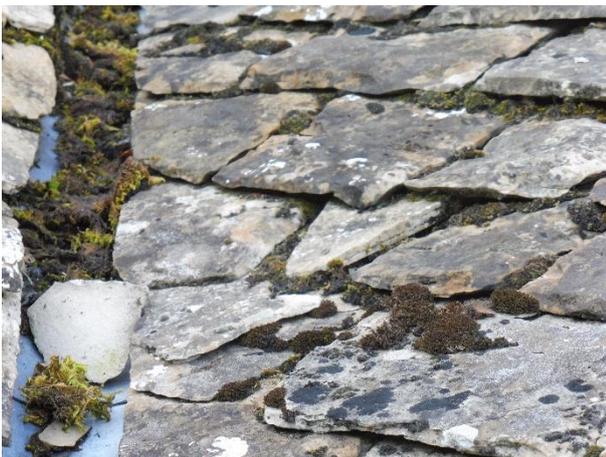
Vestry east – Damaged, slipped and missing slates.

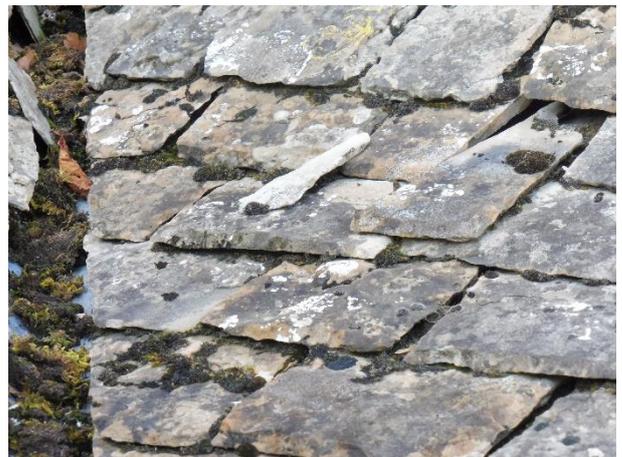
Vestry east – Slipped slates.

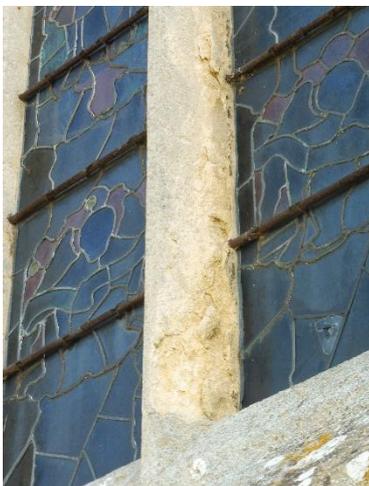
North Aisle – Erosion and minor fractures to mullion and rusting external saddlebars.

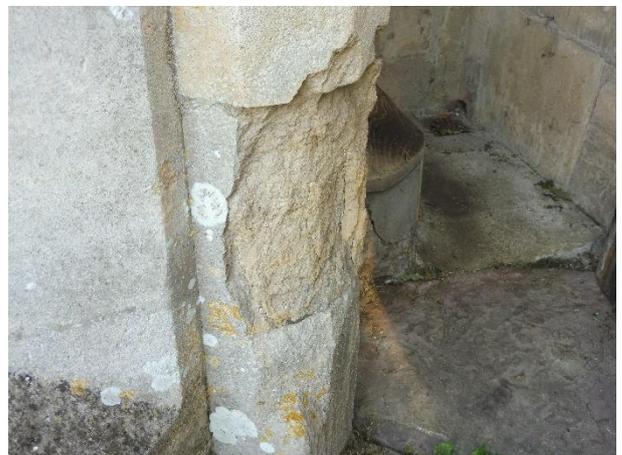
Turret staircase doorway – Heavily eroded jamb.

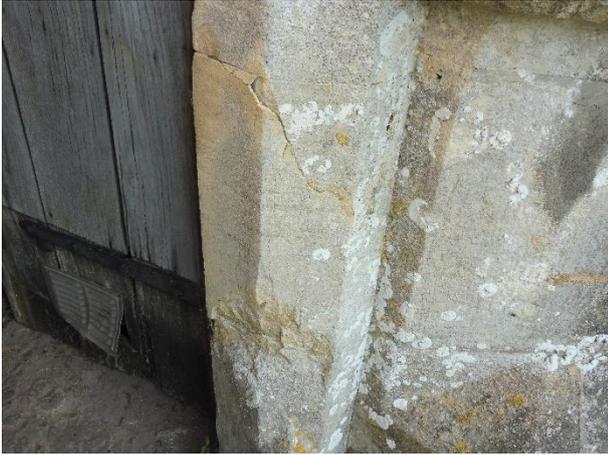
Turret staircase doorway – Fractured jamb.

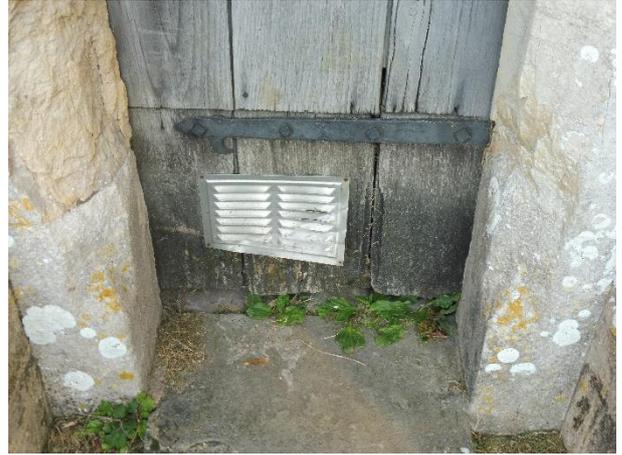
Turret staircase doorway – Splits to boarding and defective vent.

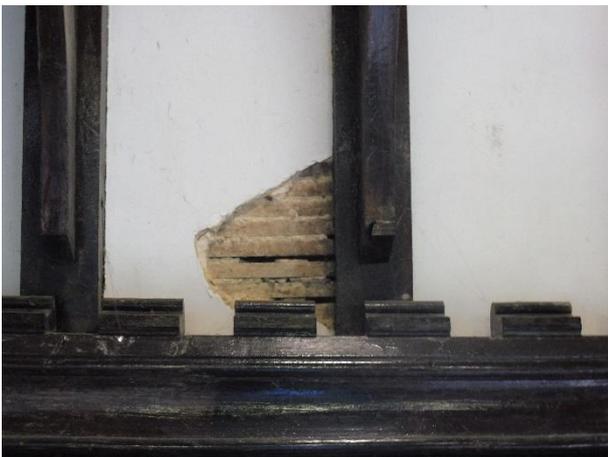
South Porch – Damage to lath and plaster ceiling.

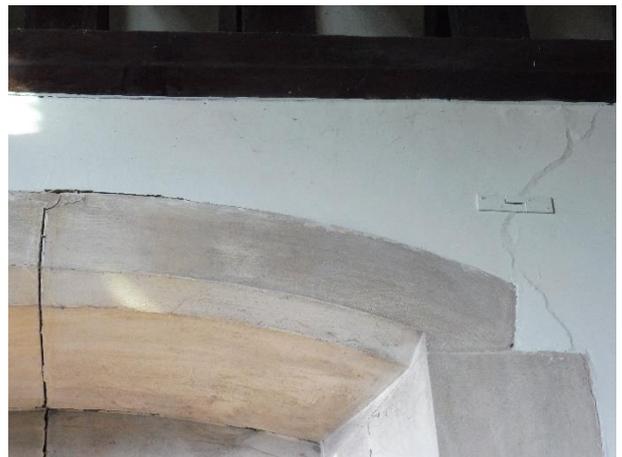
North Aisle – Movement above east window with tell-tale installed.

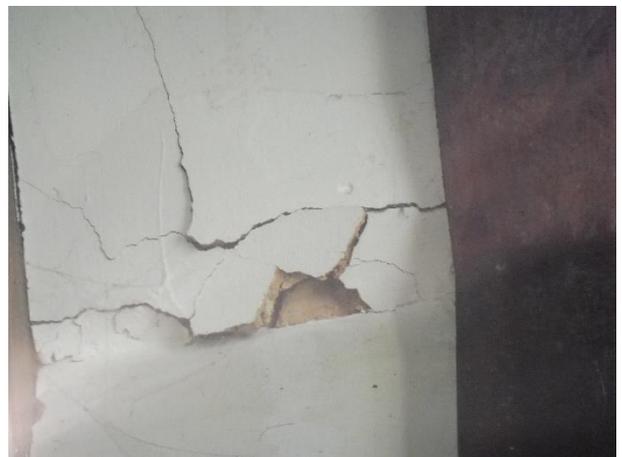
North Aisle – Damaged plaster.

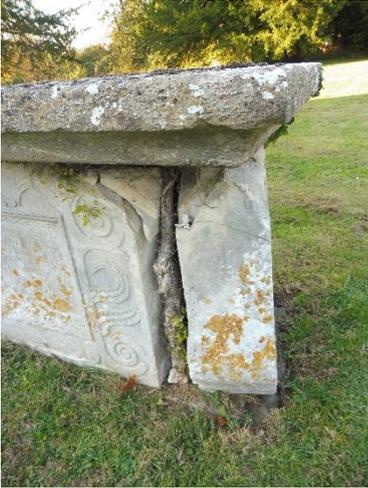
Churchyard monument – Damage and movement.

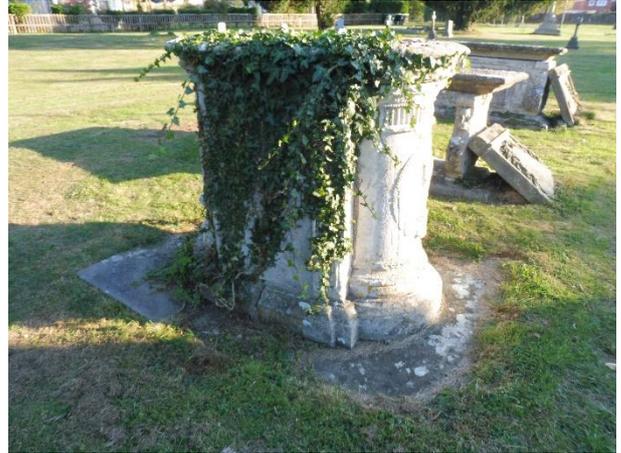
Churchyard monument – Vegetation.
